McGinnis Chen Associates Inc
ARCHITECTS | ENGINEERS

Re: 450 N Street Vision Glass 18th Floor Cracks – #12080.00 RP
Subj: Letter Report

This letter contains the investigation comments and findings for the reported vision glass crack May 01, 2012 at the Board of Equalization (BOE) Building (Project) located at 450 N Street in Sacramento, California.

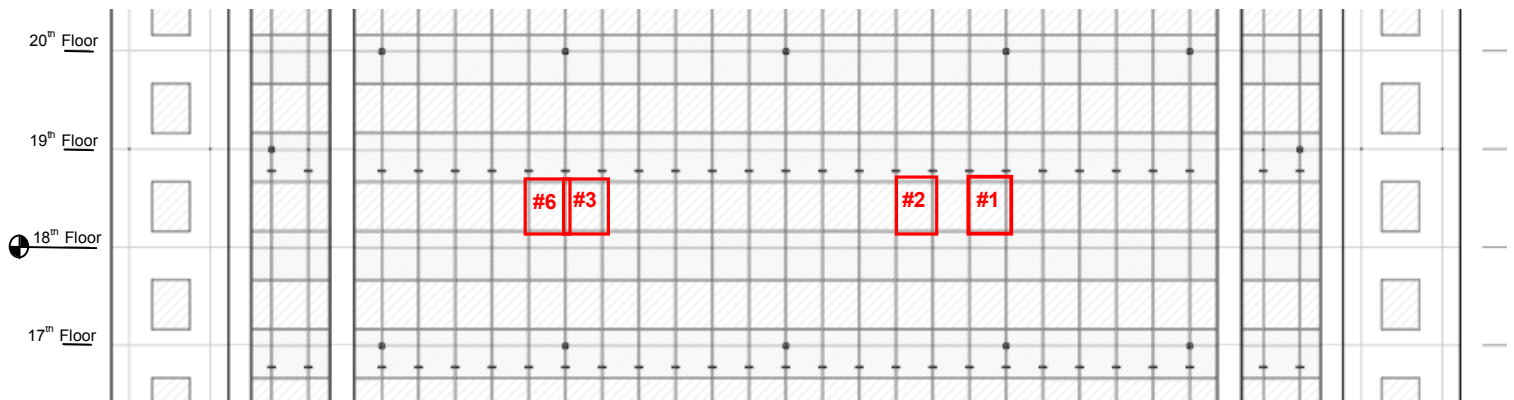
*Figure 1 – Partial North Elevation, Vision Glass (#1, #2 & #3) observed with surface cracks on May 01, 2012.
Vision Glass #6 was observed to have a surface flaw during the glass removal on May 18, 2012.*

Two workers who occupy the cubicles near the vision glass in Figure 1 marked #1 and #2 reported hearing straining noises and a cracking/popping sound before noticing cracks in the #2 glass. The workers were relocated and the cubicles adjacent to the observed cracked vision glass were taped off to prohibit entry.

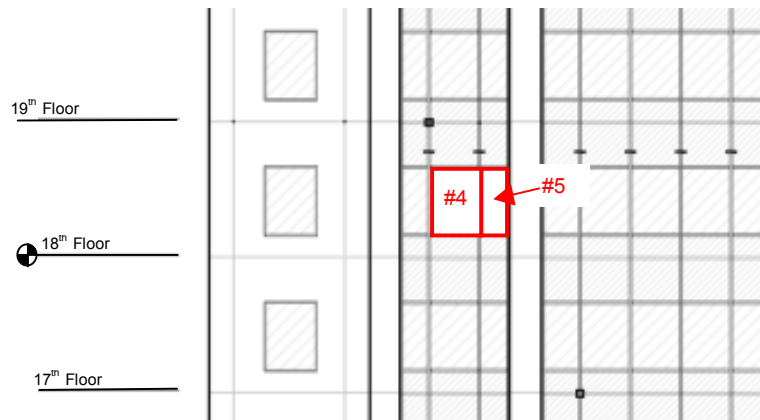
Prior to MCA's arrival, cracks were observed and reported at two other north elevation locations (Figure 1 – identified as #2 and #3) and two locations on the west elevation (Figure 2 – identified as #4 and #5).

Figure 2 – Partial West Elevation – Vision glass (#4 & #5) observed with surface cracks on May 1, 2012

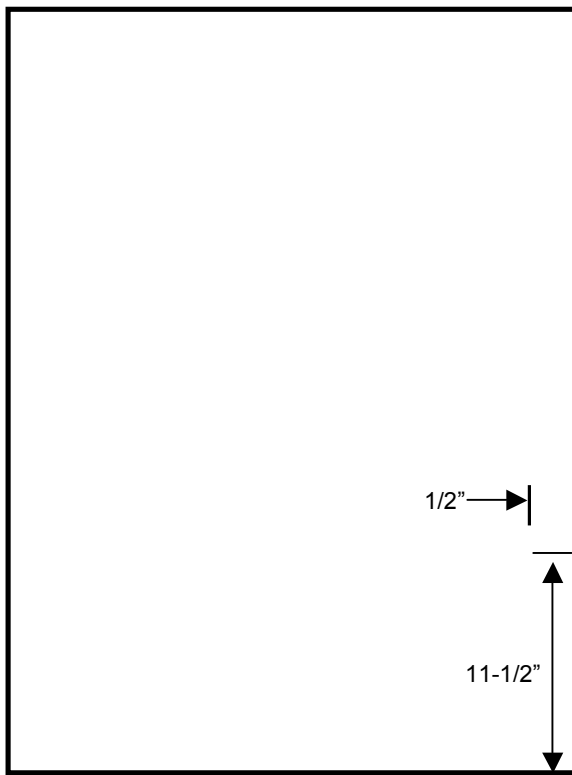
Vision Glass #2 Interior Elevation

#2	S	See Appendix A – Vision Glass #2 ; Three cracks (smooth) originating from a rough edge condition.	Good	No Obstruction	#4	Yes
#3	S	See Appendix A – Vision Glass #3 ; Single crack originating from the right mullion.	Good	No Obstruction	#4	Yes

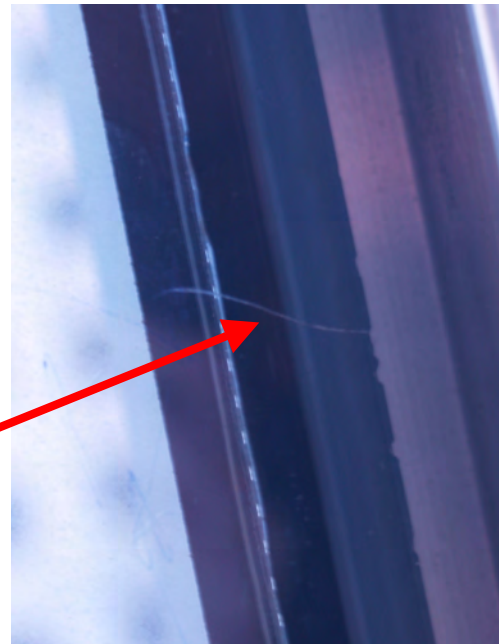
Photograph of crack and edge flaw.

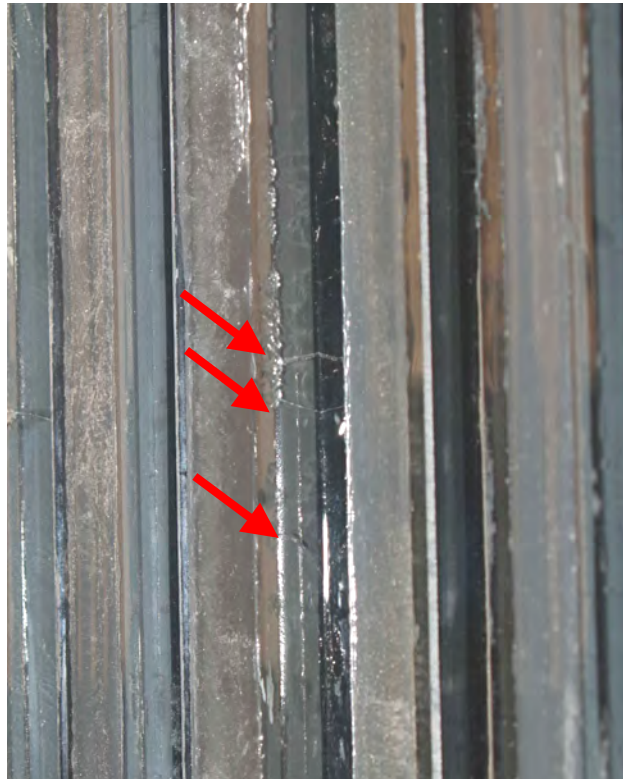
Edge view of edge flaws and cracks.

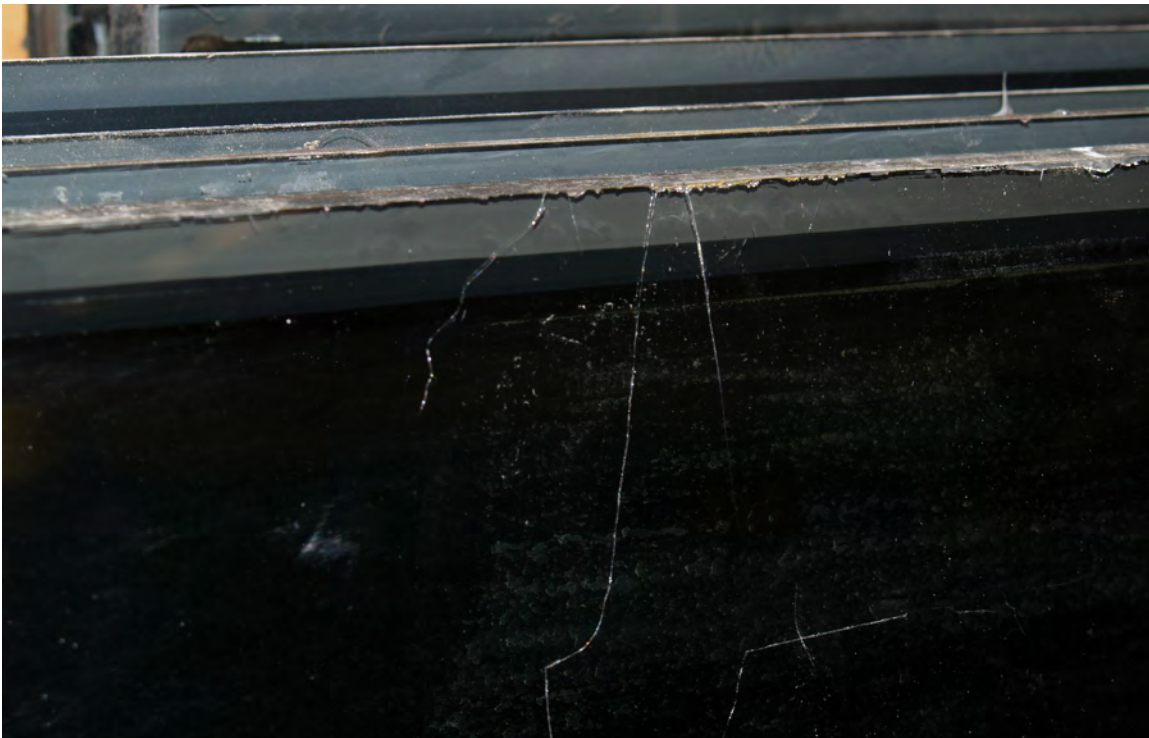
View of cracks in Vision Glass #2

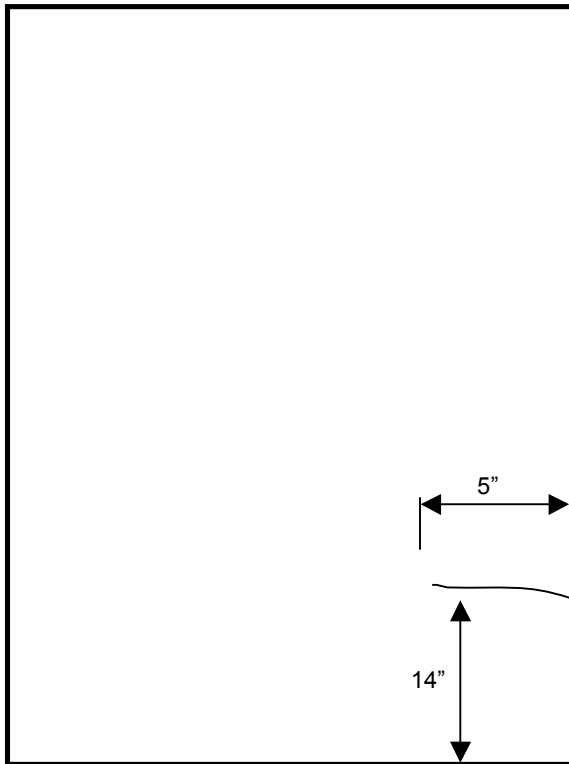
Vision Glass #3 Interior Elevation

Note – No good photographic documentation of Vision Glass #3 was obtained.

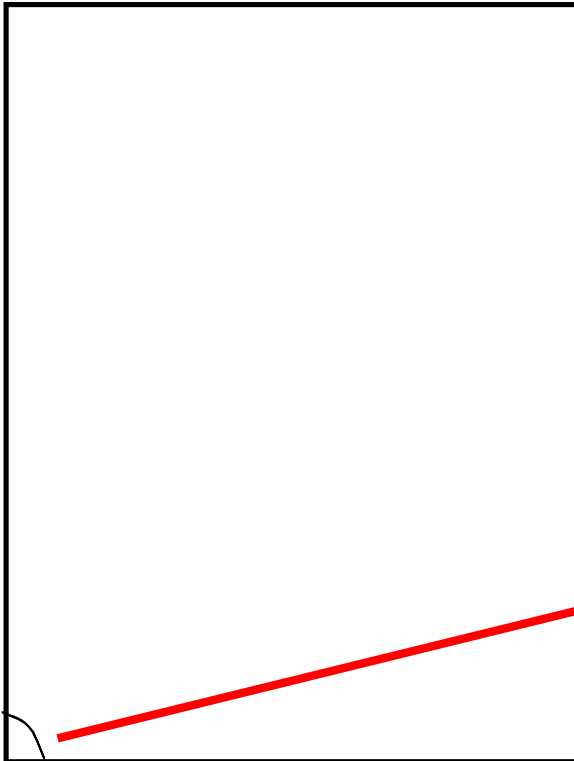
Vision Glass #4 – Interior Elevation

#4	W	See Appendix A – Vision Glass #4 ; Single scratch (rough surface) at sill near left corner.	Good	No Obstruction	#3	No
#5	W	See Appendix A – Vision Glass #5 ; Arcing crack at bottom left corner.	Good	No Obstruction	#4	Yes

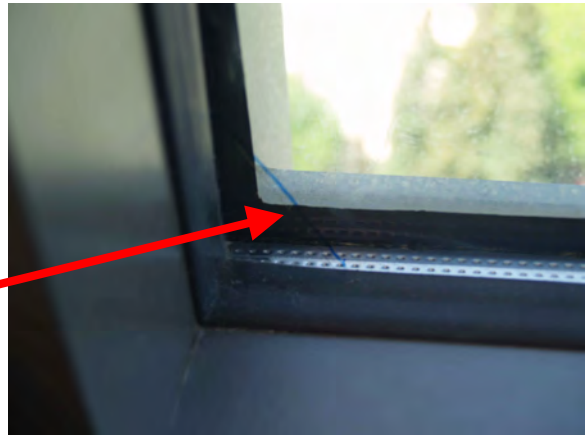
Photograph of crack in Vision Glass #4

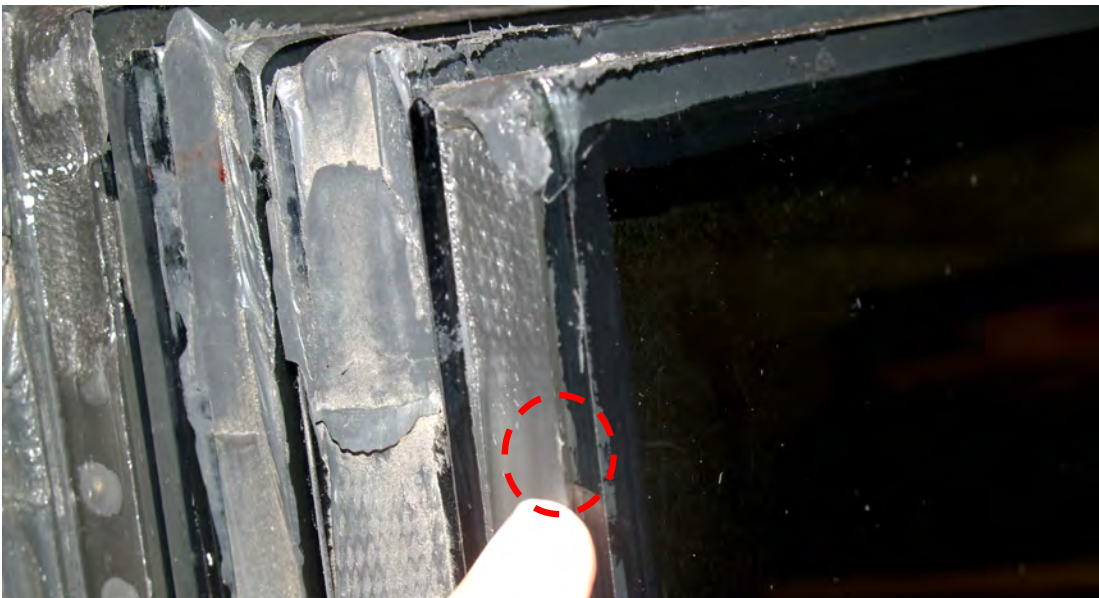
Photograph of break at edge of glass on plane #3 (inside face of interior sheet of glass). Some edge flaw condition is encountered.

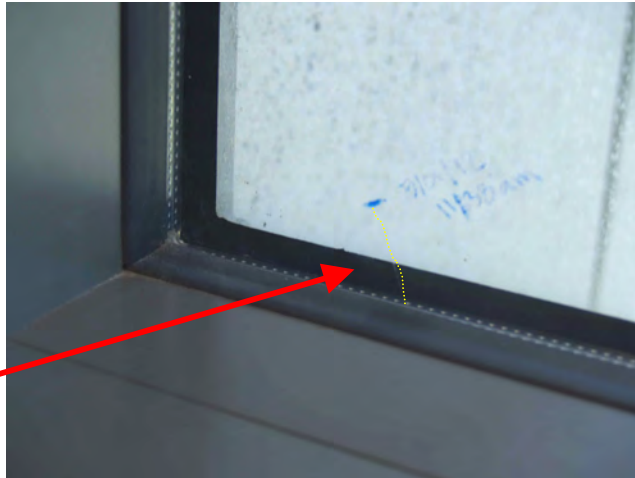
Photograph of scratch in Vision Glass #5

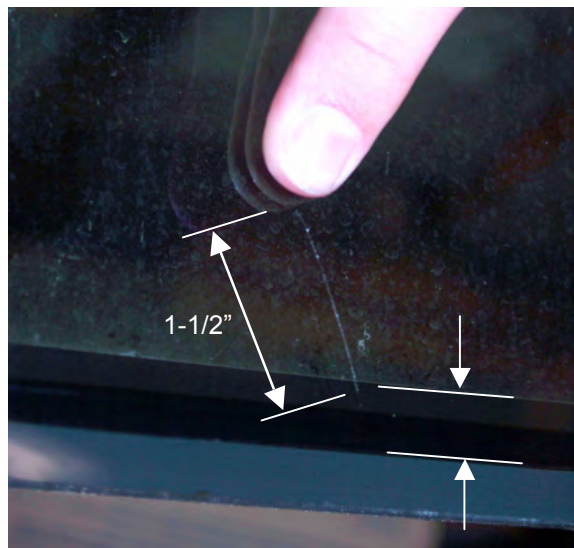
Photograph of scratch, note the distance
to the edge of glass the scratch is.

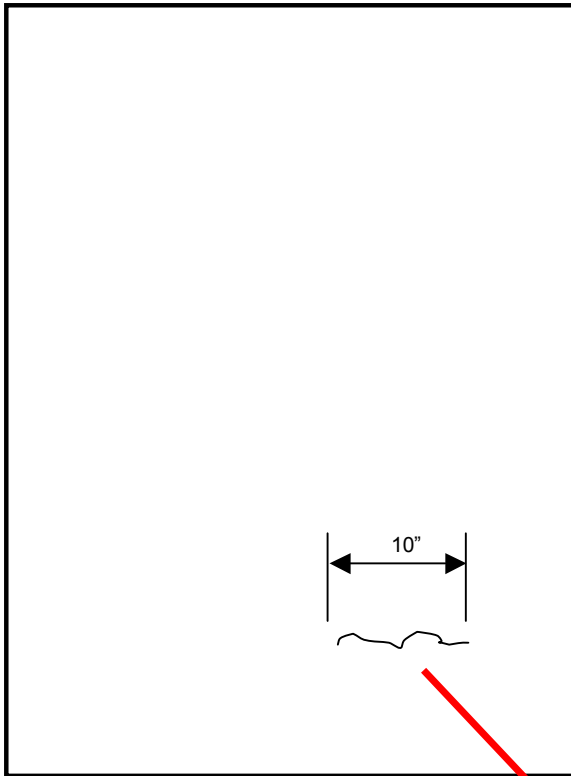
Vision Glass #6 – Interior Elevation

#6	S	See Appendix A – Vision Glass #6 ; Single scratch (rough surface) in the middle of glass. No edge origination. Uneven texture of the flaw, and multi-directional.	Good	No Obstruction	#4	No

The scratches are most likely from the time of original construction. MCA attempted to reproduce the scratches using several common tools but was unsuccessful, as the force of one individual could not attain the pressure needed to make a scratch.

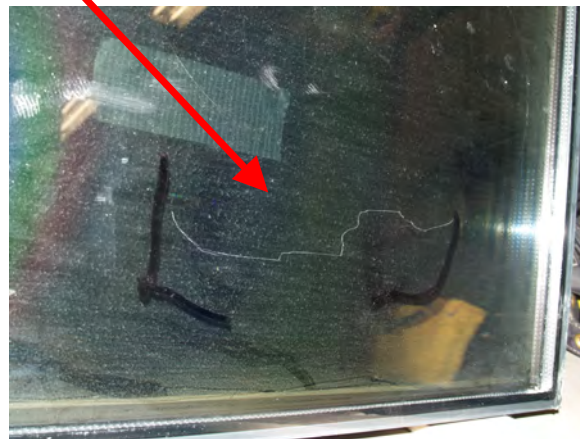
Photograph of surface flaw on Vision Glass #6
